NUMBER 24 1959-60 Mini

The original Mini was pushed through production so quickly it didn't get tested properly, leading to various problems. Most cars were fixed, but some still slipped through the net.

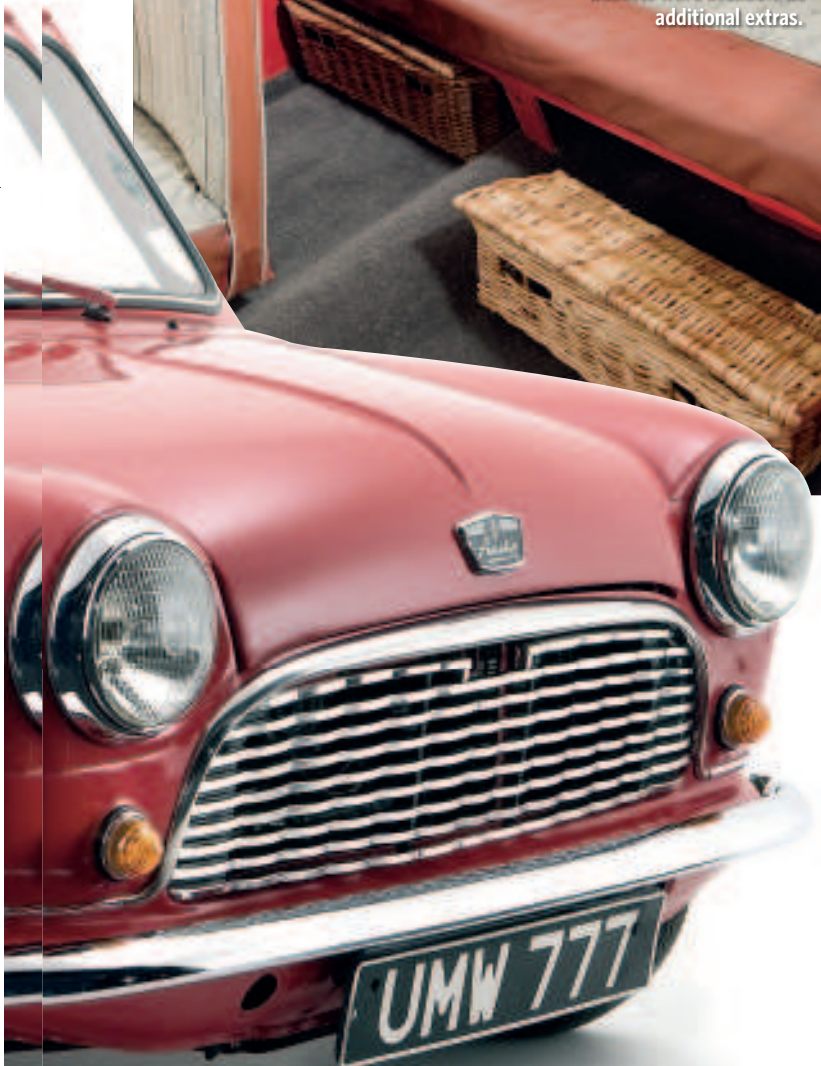
Under-seat wicker picnic baskets were available as additional extras.

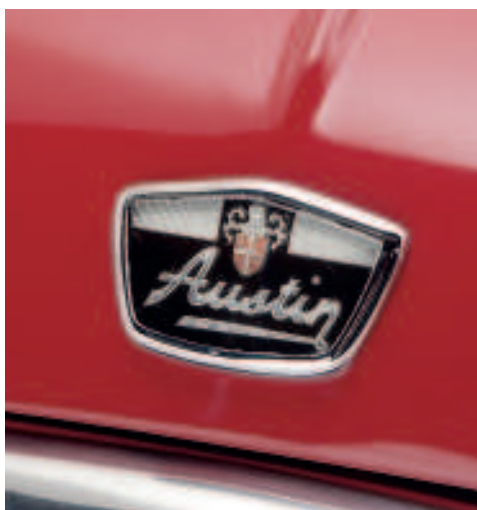
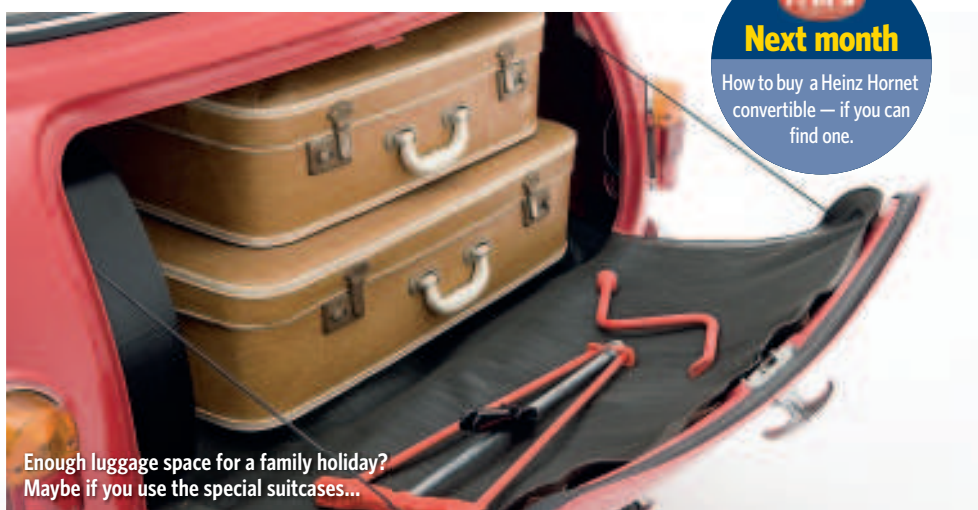
Enough luggage space for a family holiday?
Maybe if you use the special suitcases...

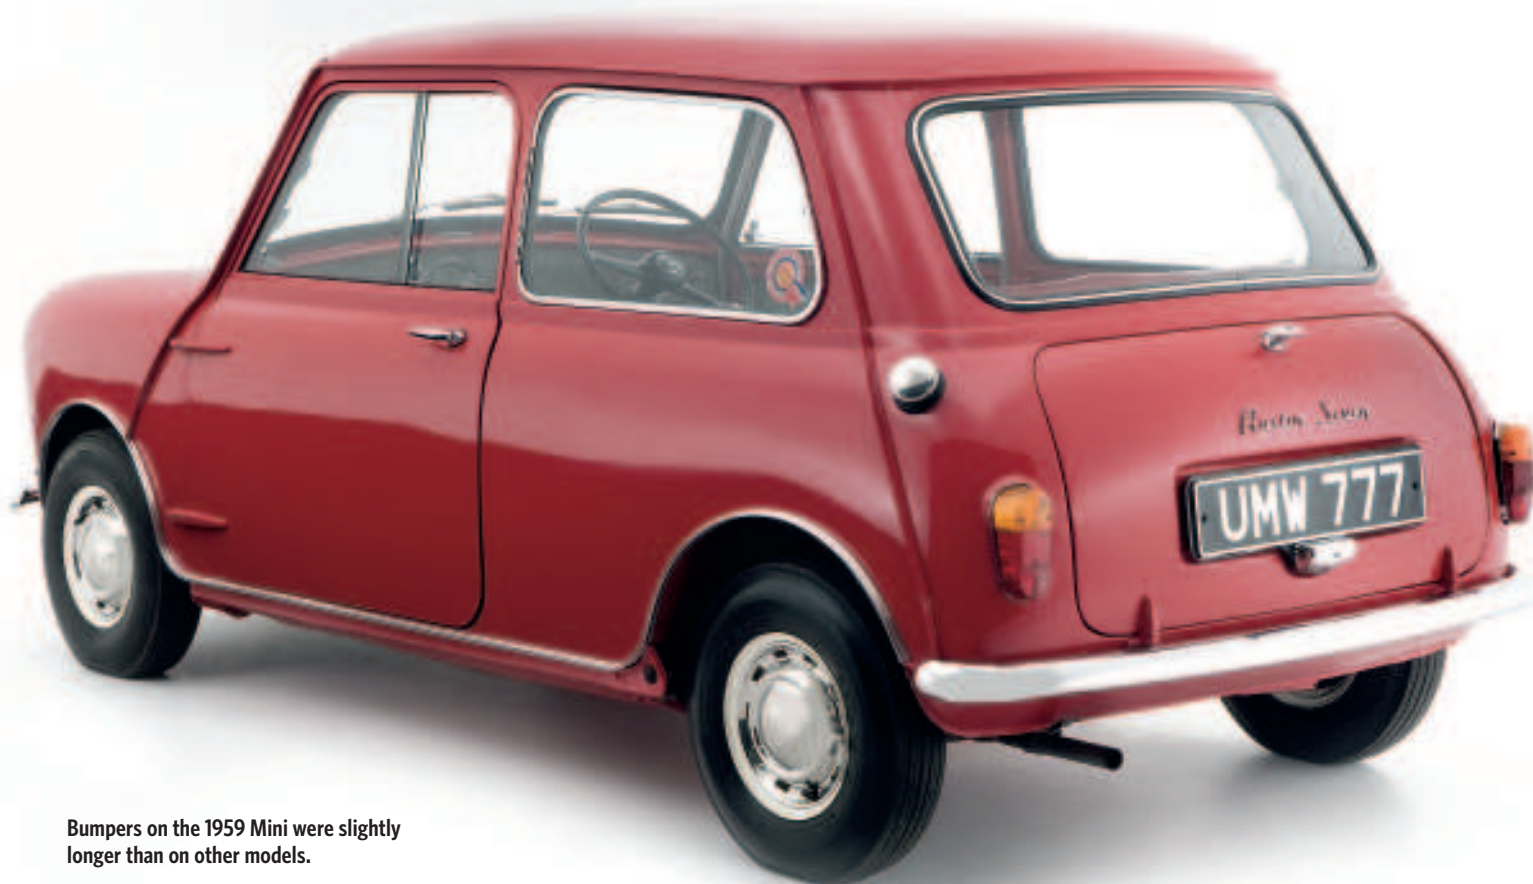
Bumpers on the 1959 Mini were slightly longer than on other models.

- **Bumpers.** The very first 1959 chrome front and rear bumpers were slightly longer than those fitted to 1960-on Minis.
